# **An archaeological investigation of the Roman aisled stone building at Hog Brook, Deerton Street, Faversham, Kent 2004-5**

**The Kent Archaeological Field School**

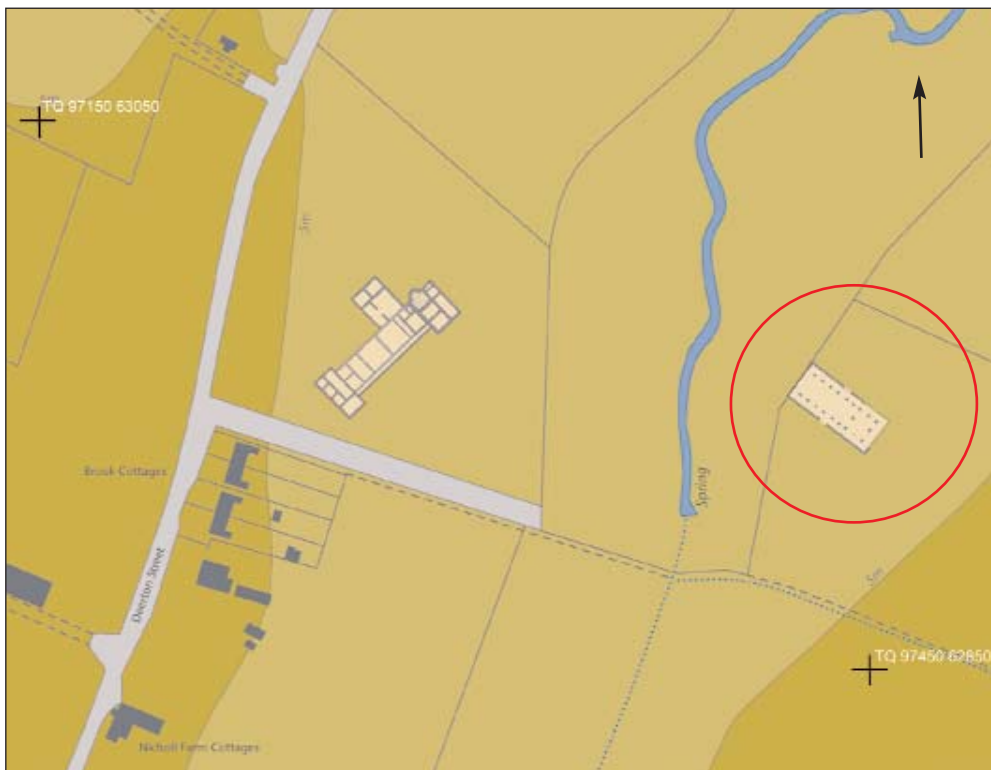
**Fig. 2.** The spring at Deerton Street is called Hog Brook. To the west (left) is a large and substantial Roman villa located by Paul Wilkinson as part of a landscape survey for Swale Borough Council (Swale Survey 2000). Investigation with the Kent Archaeological Field School (KAFS) took place over four summer campaigns. An interim report was published in 1997 (Appendix 7). The villa is about 49m (160ft) long and includes a apsed bath suite decorated with painted plaster and a tessellated floor. The stone aisled barn to the east of Hog Brook was, also, found through field-walking by Paul Wilkinson. More Roman building have been located to the north of the main villa.

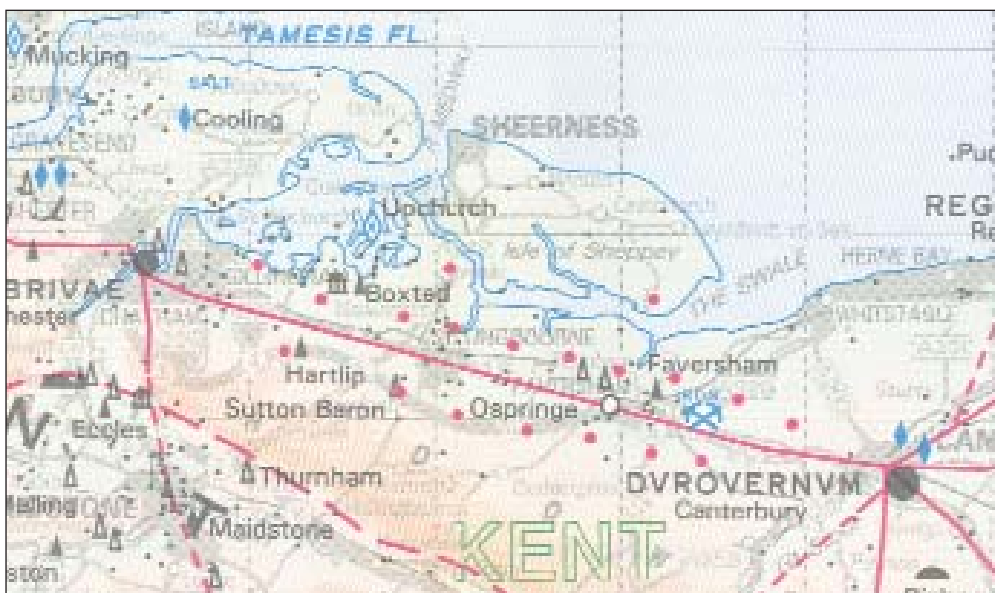
**Fig. 3.** Four years of field-walking in the Swale District in Kent led to the discovery of 18 potential Roman villa sites both north and south of Watling Street (Wilkinson 2000). The pattern of these villas suggest control by the Roman authorities. Each villa north of Watling Street seems to have been allocated about 2000 acres of land, whilst the villas south of Watling Street which were situated on less productive land seem to have been allocated about 2500 acres.

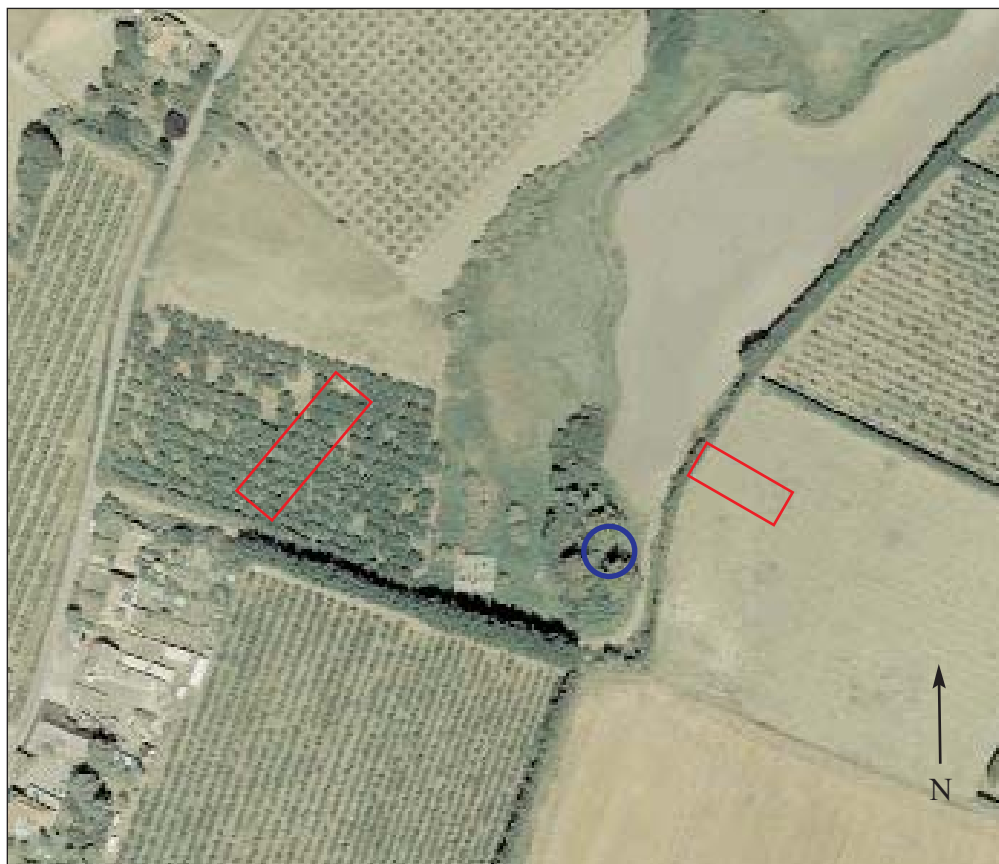
**Fig. 7.** The Roman villa estate of Deerton Street is focused on the fresh spring water supply from Hog Brook (blue) which flows into the Swale estuary about 1km away. The Roman villa faces south-east overlooking the spring of Hog Brook. The large basilican barn is situated on the east bank of the spring with direct access from the building to the sea. This would enable the many hundreds of tons of stone and building material to be brought in by sea. Agricultural produce could also be exported by sea, to London, Rochester and /or Richborough, or indeed directly across the North Sea to the armies of the Rhine.

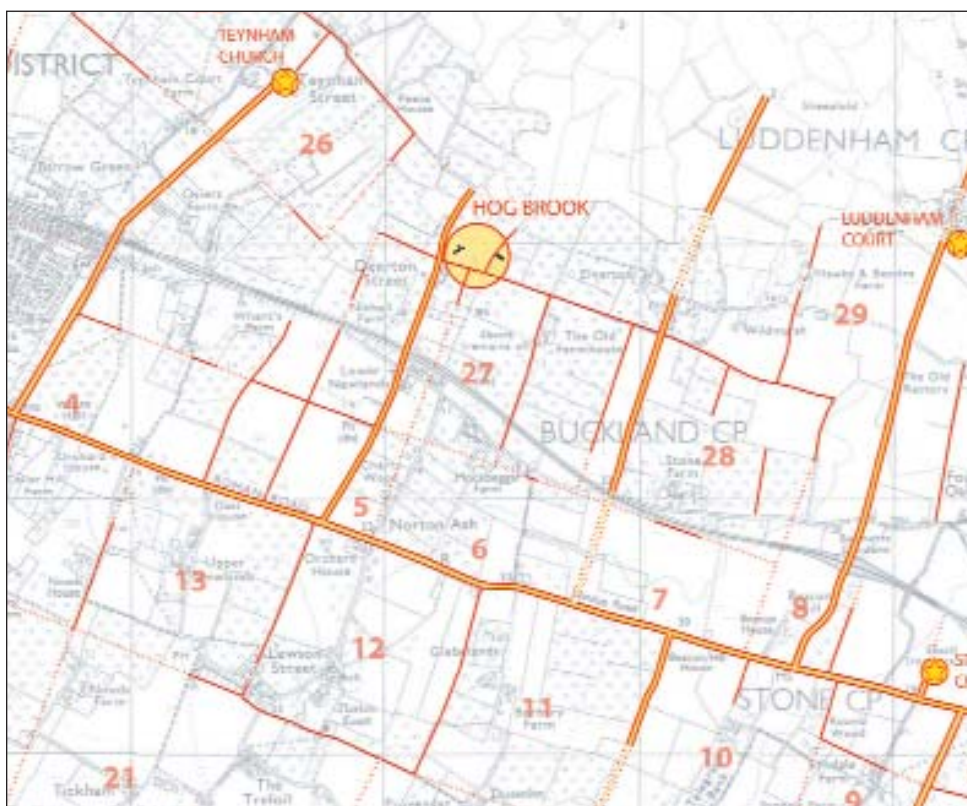
**Fig. 9.** Part of the investigation methodology of the KAFS is not to treat sites in isolation, but integrate the sites into the landscape. The results have been encouraging. The landscape around Hog Brook and Deerton Street can now, even after 1900 years of agricultural activity, be seen to have been divided up into 20 *actus* squares by Roman surveyors. There are 17 centuriation squares running in sequence along Watling Street in the vicinity of Hog Brook with another 12 clustered around the Roman villa estate of Deerton Street. See Figure 12 for the full extent of investigation.

Part of the investigation methodology of the KAFS is not to treat sites in isolation, but integrate the sites into the landscape. The results have been encouraging. The landscape around Hog Brook and Deerton Street can now, even after 1900 years of agricultural activity, be seen to have been divided up into 20 *actus* squares. There are 17 centuriation squares running in sequence along Watling Street in the vicinity of Hog Brook with another 12 clustered around them (Figure 12).

along Watling Street in the vicinity of Hog Brook with another 12 clustered around them (*above*). All of the centuriation squares have been measured on the ground and are within a few metres of 706m, the length of a 20 *actus* square. The results of this important large-scale investigation of Roman land measurement will be written up in a separate report (Figure 12).

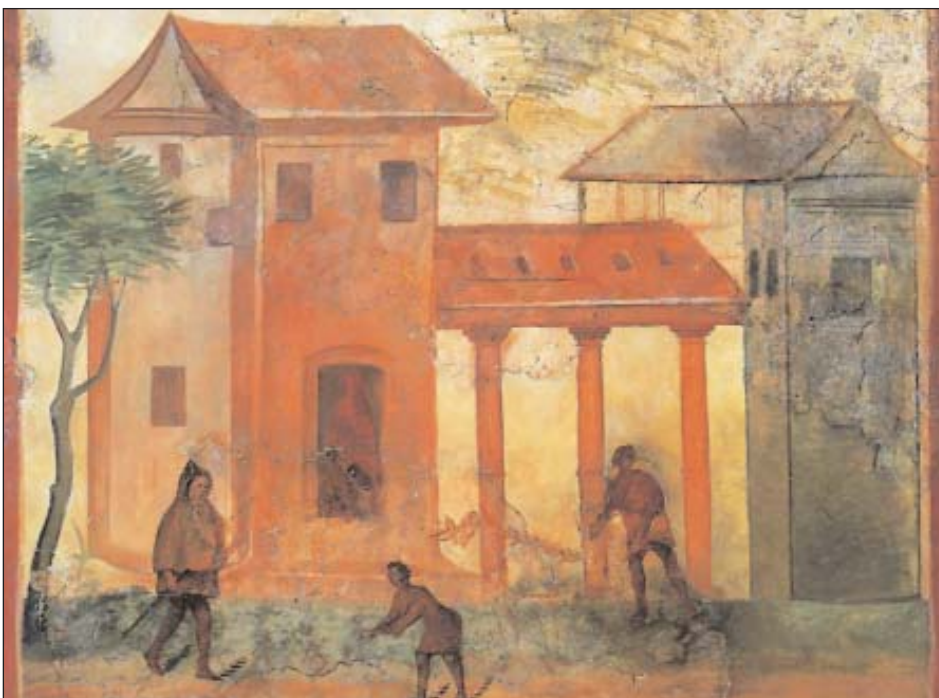
**Fig. 13.** The classic image of an European Roman villa is from Trier in Germany. The layout has been much argued over. Collingwood identifies the type as: 'The winged corridor house with the corridor running along the front of the house stopping short of its two ends, which project in wings'. The on-going discussion is whether the open space through the columns of the corridor to the rear was a courtyard or a covered hall (Smith J T 1997, 24 & Collingwood 1930, 115).

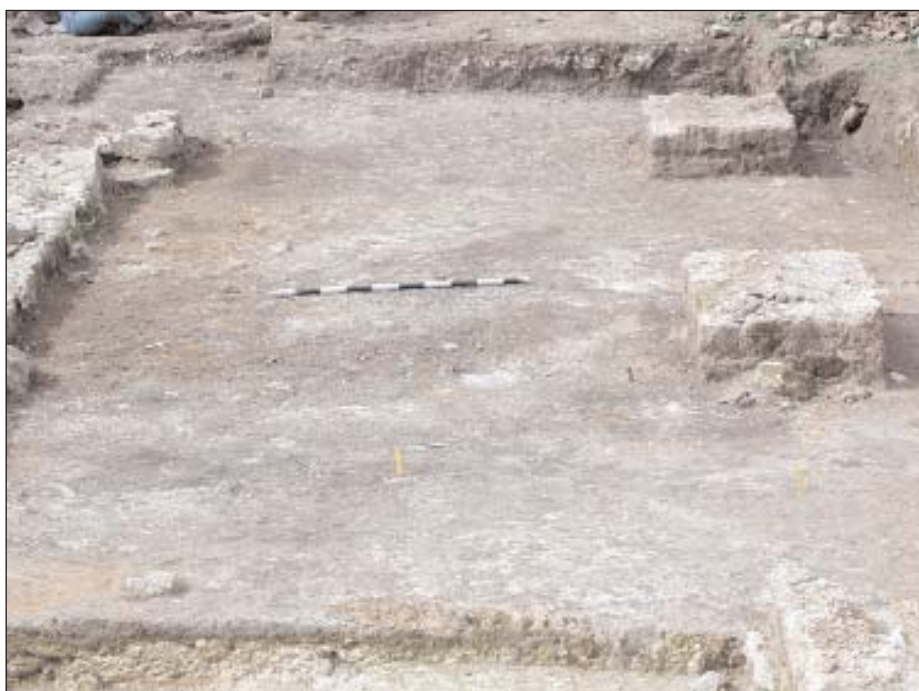
**Fig. 21.** All Hog book piers were built on substantial KRS foundations averaging about 1 to 1.50m metres deep. The photograph is looking west along the southern exterior wall with piers 12 and 13 on the right. The south entrance with its internal pier can be seen top left. The latest level of sandy floor has been removed leaving a chalk tamped surface sitting on a thin layer of re-deposited clay which overlays the natural chalk. This can be seen in the section at the bottom of the photograph.

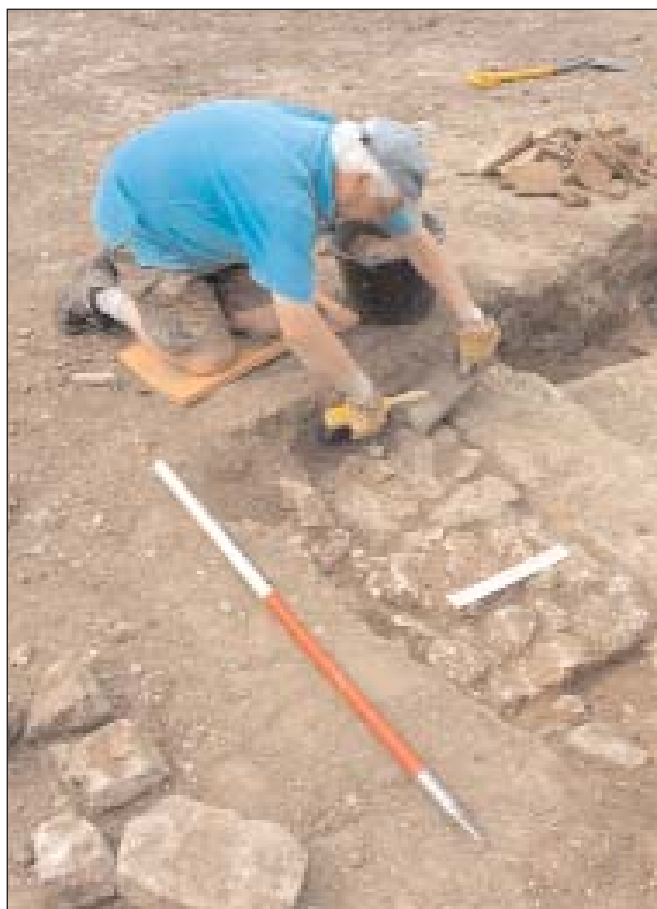
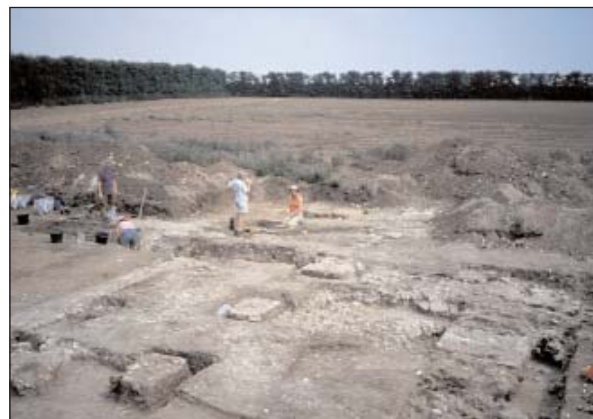
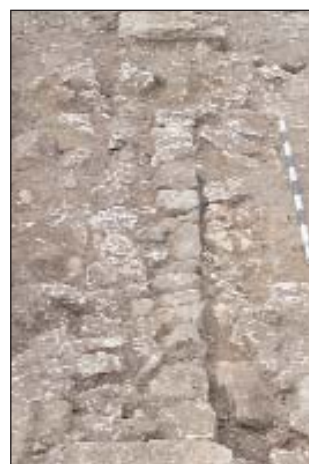
**Fig. 22.** The distance between the two runs of foundation piers at Hogbrook is 7.48m. At Birdoswald the distance between the two sleeper walls was also 7.48m. Here a KAFS archaeologist is peeling back the demolition layers to expose the internal walls and Pier 8.

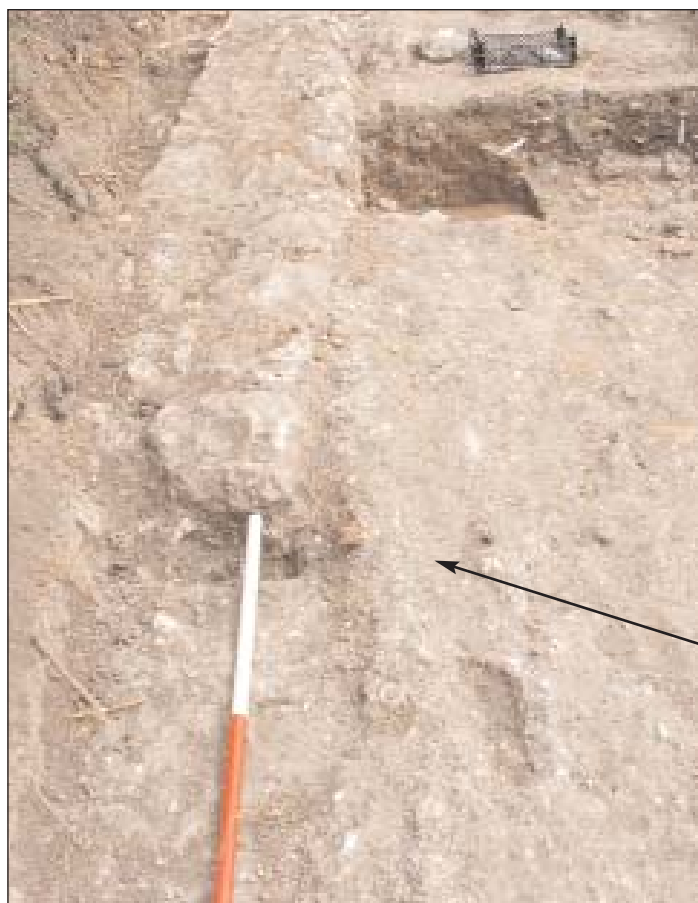
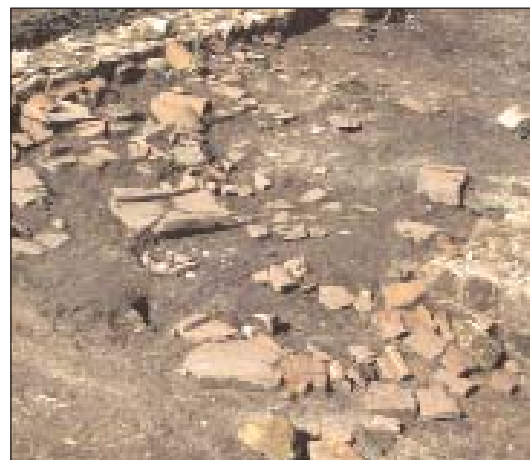
**Fig. 23.** A mortar mix for a wooden beam slot was laid just inside the collapsed west wall and presumably a wood partition wall was built to replace the end wall. Pottery sherds retrieved from the floor context below the beam slot

The wall was not repaired, instead a mortar mix for a wooden beam slot was laid just inside the collapsed wall and presumably a wood partition wall was built to replace the end wall (Fig. 23). Pottery sherds retrieved from the floor context (071) below the beam slot (070) are Anglo-Saxon ware dating from AD450-650.

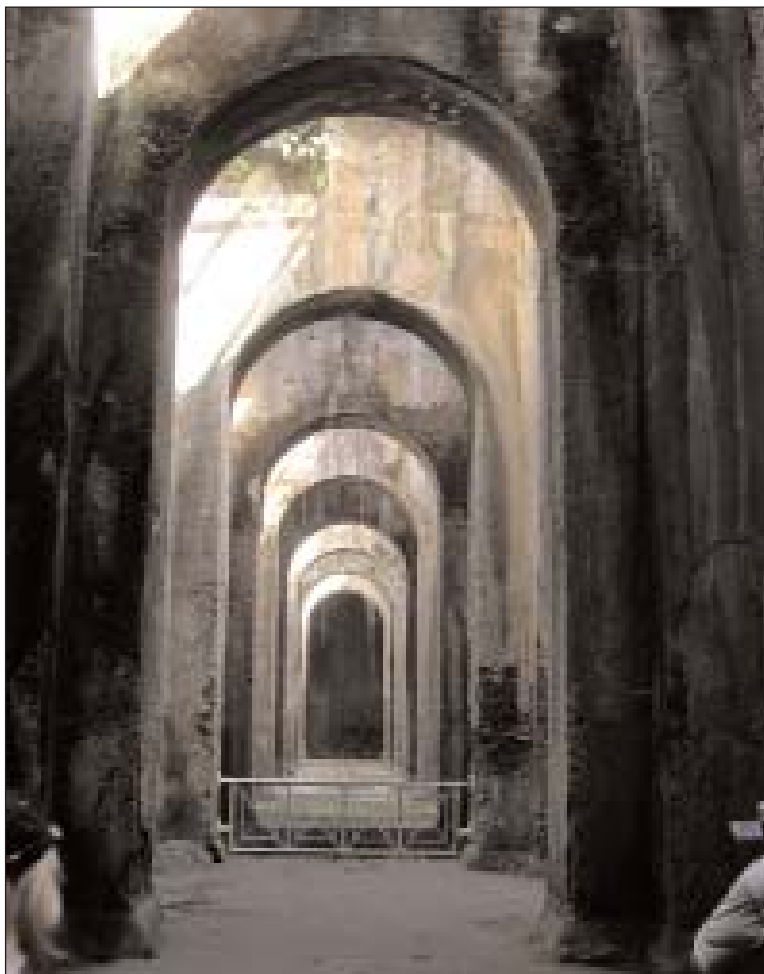
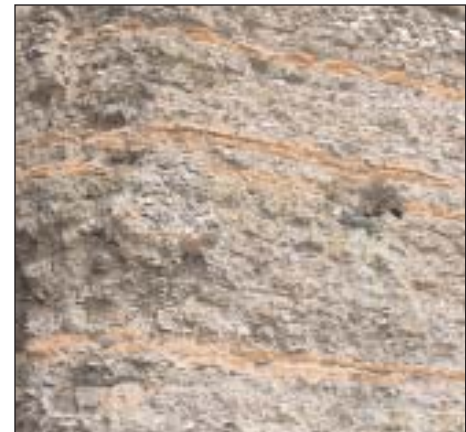
**Fig. 25.** The Piscina Mirabile at the Roman naval base of Misenum near Naples (*left*) utilises the use of the arch in five pillared aisles. Here the clerestory lighting illuminates the interior in exactly the same way as it would have done at Hog Brook. The photograph (*above*) of double brick lacing on the Roman lighthouse at Dover shows that this feature, also seen on the collapsed pier at Hog Brook was to bind together the courses of stone facing and core whilst the mortar was still soft. Another function was to level off the wall and keep the build horizontal.

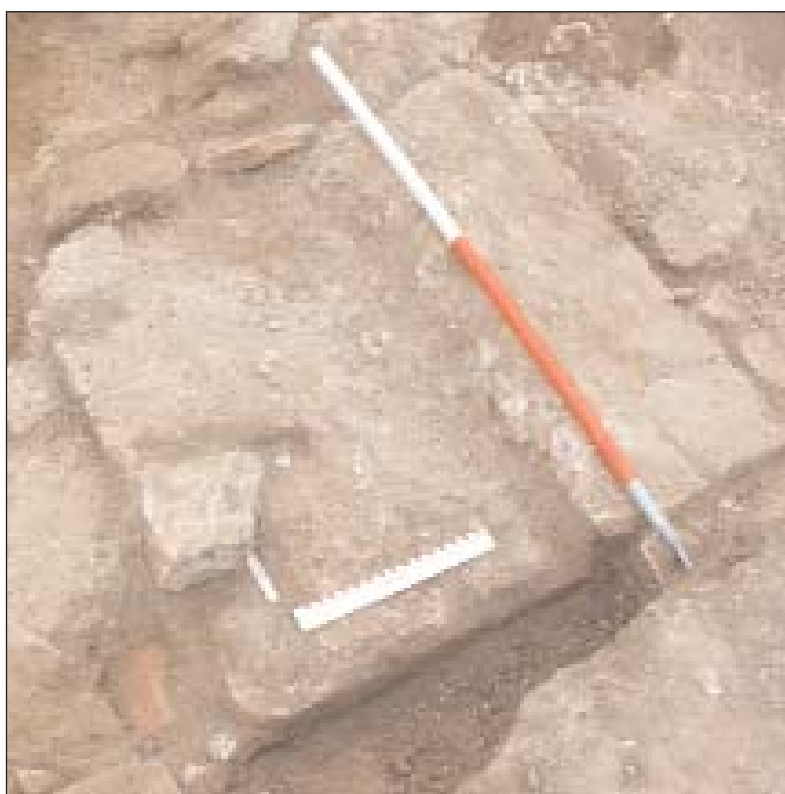
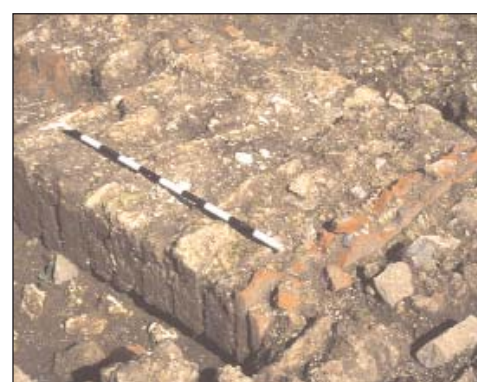
**Fig. 26.** Pier 8 (*left*) shows the use of Tufa blocks with rounded corners. The collapsed rectangular Pier A (*above*) shows the use and brick in its construction. Calcareous tufa as used in the build of the piers is a light

Pier A is situated in the centre of the building at the east end, and at 1.24m by 96cm is one of the larger piers found in the building. It has two vertical rebates on its east face (Figure 3) with rounded corners and faced with 20-30mm of off-white lime plaster. The pier base stands about 290mm above the latest Roman floor. The pier itself has collapsed and fallen slightly skewed to the west. The pier is built of Tufa blocks about 80mm thick set in mortar about 40mm thick. About 5m of the pier survived the fall. Every 1.15m a horizontal double layering course of Roman tiles were laid (Fig. 26).

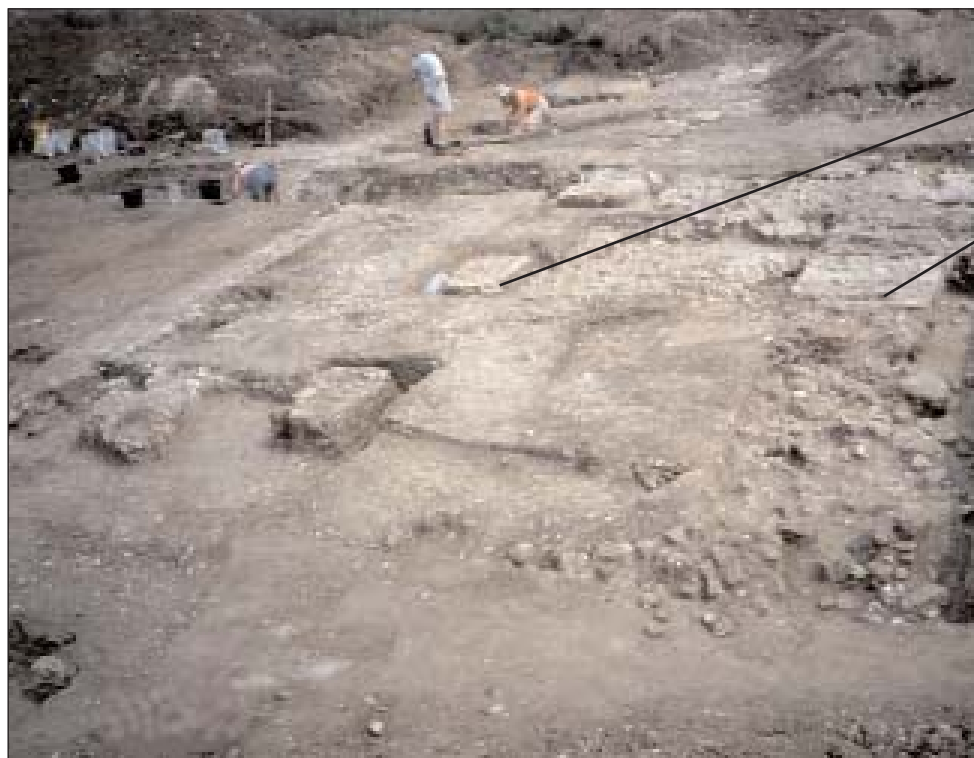
**Fig. 28.** The site looking north-east. The aisled piers 4, 5, 6, can be seen inside of the north wall whilst the collapsed pier of Pier A is on the right of the picture. Excavation is underway on the 1st century ditch (059) which predates the building. The two figures are excavating an Anglo-Saxon rubbish pit (030) and retaining the contents for analysis.

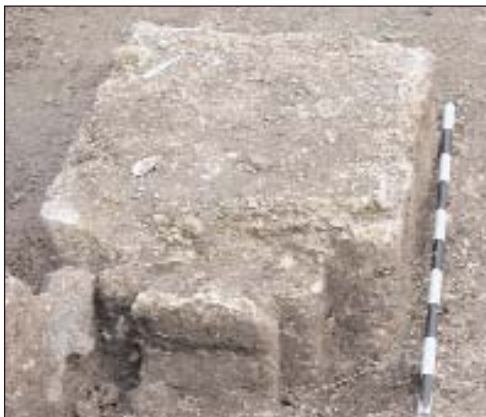
**Fig. 29.** Pier 13.

The pier was not faced with mortar/plaster finish, but was rounded on all eight corners. The pier base survives about 240mm above the Roman floor level. The pier is unique in that it is rebated vertically with two vertical rebates, and a horizontal groove. It is likely that the rebates were to hold some sort of timber stalling, the reconstruction of which requires further research (Figure 3).

**Pier 13.** Located in the south area of the building and measuring 0.65 x 0.91m. Surviving height was at 4.55m OD. The pier, built of Tufa blocks which each measured about 200mm x 310mm, and about 90mm thick were laid in a thick layer (16mm) of white/gray mortar mixed with occasional brick flecks (Fig. 29 below). The central infill was Kentish Ragstone nodules and/or chalk set in the same type of mortar. The pier was not faced with mortar/plaster finish, but was rounded on all eight corners. The pier base survives about 240mm above the Roman floor level. The pier is unique in that it is rebated vertically with two vertical rebates, and a horizontal groove. It is likely that the rebates were to hold some sort of timber stalling, the reconstruction of which requires further research (Figure 13).

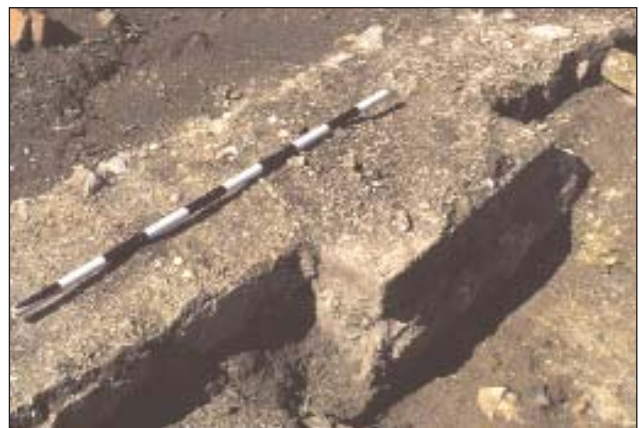
An engaged pier was located on the inside face of the west wall (Fig 30), and this pier was in line with the piers 0-8. It was built of Tufa blocks with no evidence of keying into the main exterior wall.

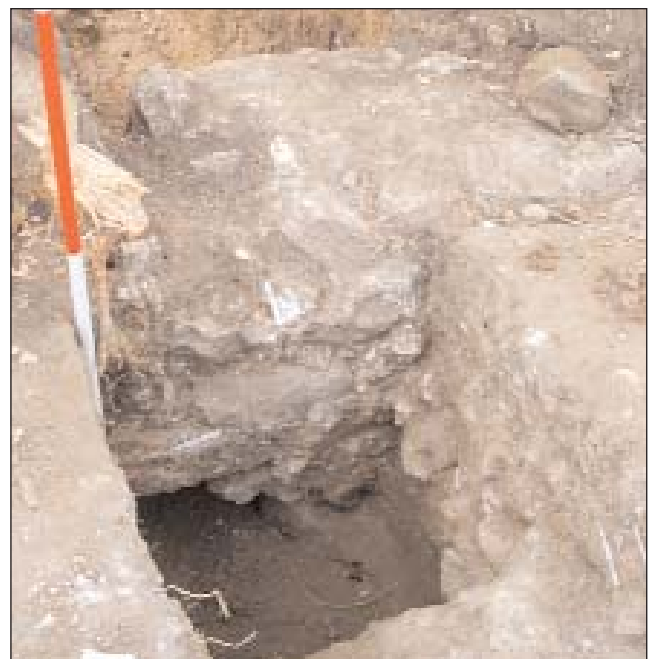
**11.5. The south-west area.** Under the west end wall of the aisled building was a massive deep drain or conduit (Fig. 31) which ran out into the spring (Sections 16, 17, 18). A coin of *Allectus* found in the drain deposits (Coin 23) is dated to AD293-6. There is no evidence of the drain or

Under the west end of the aisled building was a massive deep drain or conduit which ran out into the spring (Figure 10. Sections 17, 18). A coin found in the drain deposits (Coin 23) is dated to AD293-296. There is no evidence of the drain or drainage inside of the building as it seems to be blocked by a Roman wall which may be part of a structural/stabilising construction to ensure the bank overlooking the spring was consolidated (Figure 9. Section 14).

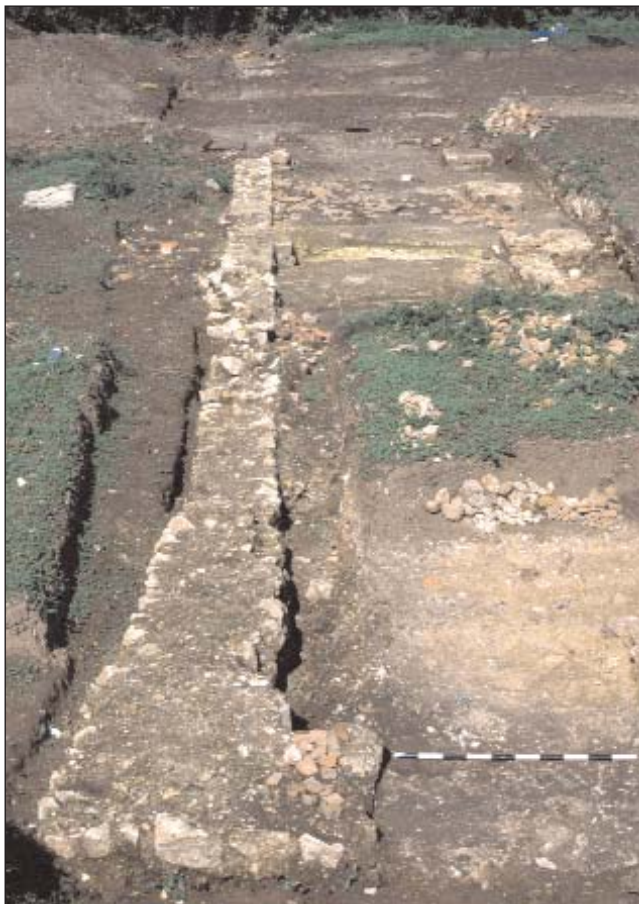
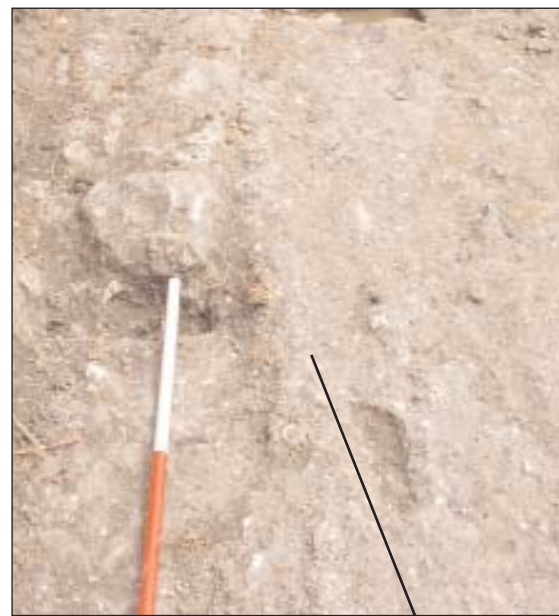
**Fig. 32, 33.** The south-east end the south wall (*left*) splays out from its standard width of about 600mm to about 1m. The west wall (*above*) collapsed and was not repaired, instead a

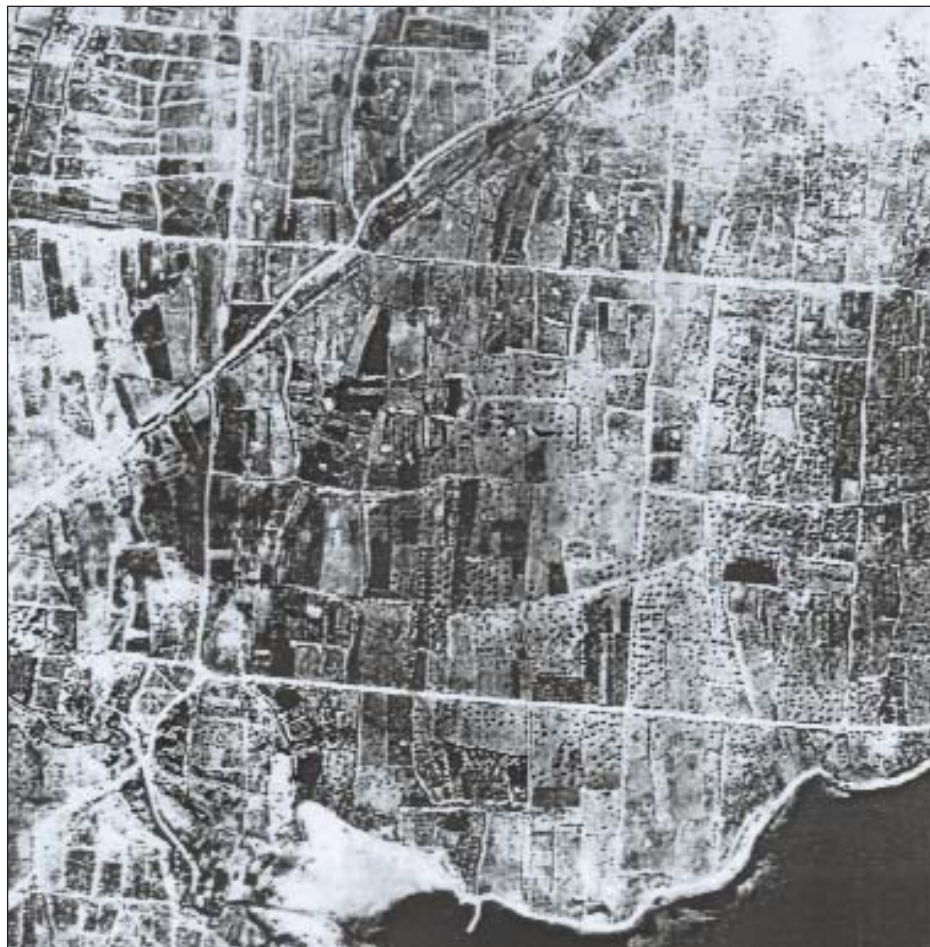
**Fig. 36.** Aerial photograph of the area around the town of Zadar in Croatia. The Roman land division in units of 20 x 20 *actus* still survives in a remarkable state of preservation. The normal size of a *centuriae* was a square of 20 x 20 *actus* measuring on one side 706m, with an internal area of about 124.6 acres (50.4 ha).

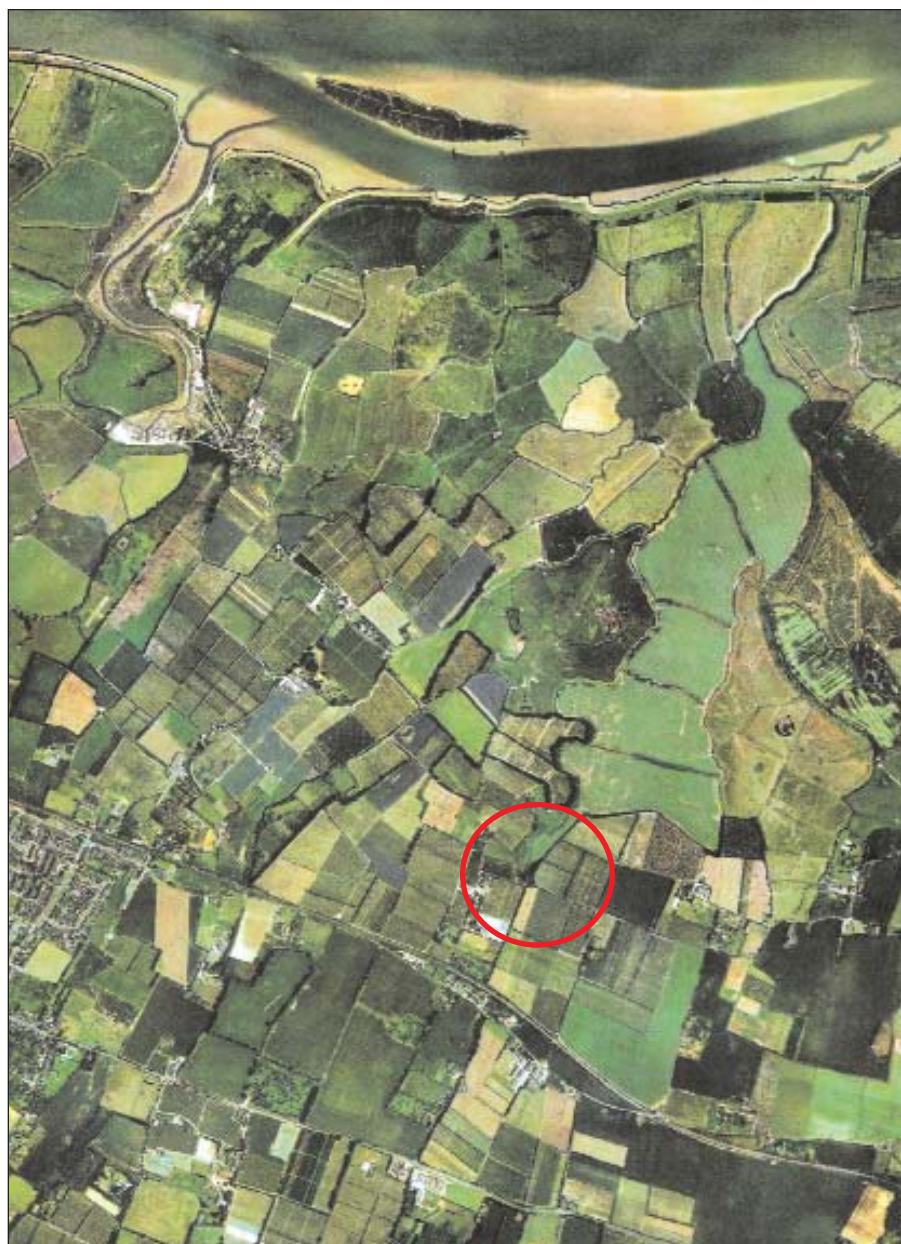
**Fig. 39.** The sites of Deerton Street Roman Villa & Hog Brook are enclosed in the red circle. They are situated on the east bank and the east slope of the west bank overlooking Hog Brook spring. Watling Street is about 1150 metres almost due south, and a straight track joins the site to Watling Street and for 400 metres of its length it is a parish boundary. Another track leads east and west in a straight line and connects the Roman villa sites of Bax Farm, Deerton Street, Luddenham and possibly ends at the spring head of Oare creek just below Bysing Wood and the Roman small town at Syndale. For over half its length it forms a parish boundary and is also a designated public footpath. There is also evidence of Roman centuriation survey methods in the layout of these roads, paths, lanes, and fields (Figure 12).
